Job Name: Keinton Mandeville

Job N^o: MNY23-01-02Date: 29th February 2024

Client: Keinton Mandeville Parish Council

Keinton Mandeville Traffic Study – Report and Recommendations

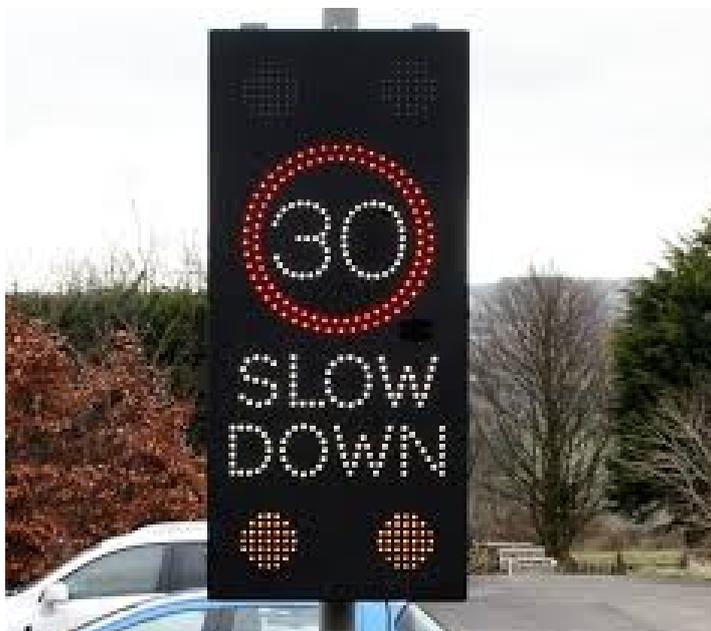
Image 1: Typical speed indicator device

Vehicle activated signs (VAS) have been developed to address the problem of inappropriate speed where conventional signing has not been effective.

There is an established relationship between vehicle speeds and road accidents. On rural roads, driving too fast for the conditions is more likely to be a factor in accidents than exceeding the speed limit. Encouraging drivers to adjust their speed to suit the conditions is particularly important, since driver error is the major contributory factor in 95 per cent of accidents. A range of rural road safety engineering measures, including vehicle activated signing, has been developed to encourage drivers to approach hazards such as bends and junctions at a safe speed, and to encourage them to comply with the speed limit, e.g. through villages. Drivers exceeding a set threshold speed trigger a sign indicating the specific hazard or the speed limit. This may be accompanied by the message “SLOW DOWN”.

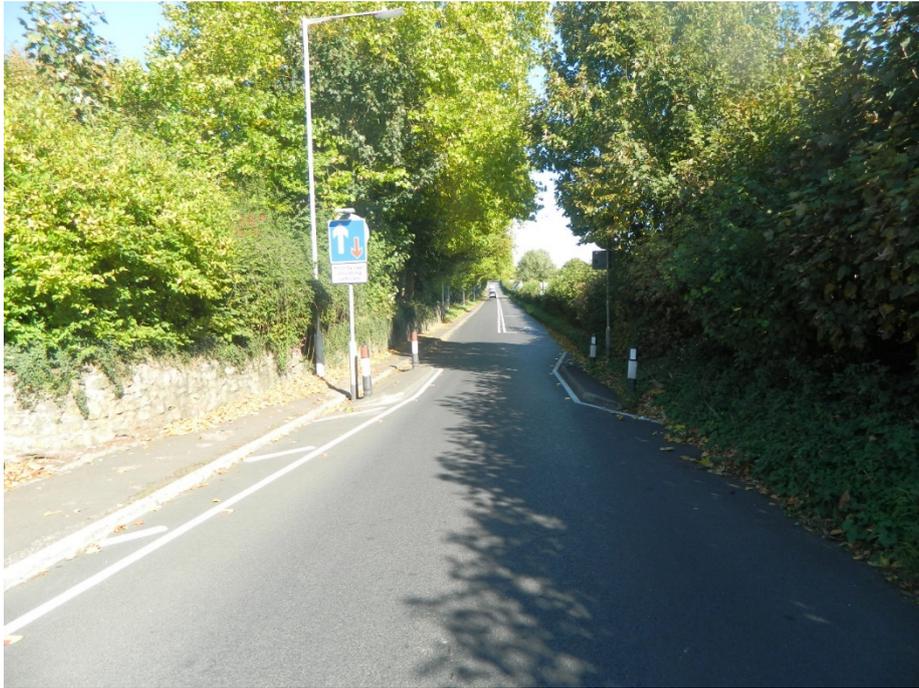
Image 2: Priority over oncoming traffic as part of traffic calming

The photographs below (images 2-4) show examples of horizontal traffic calming, these also relies on balanced two-way flows of traffic along a road. Where traffic flows are low these have reduced impact.

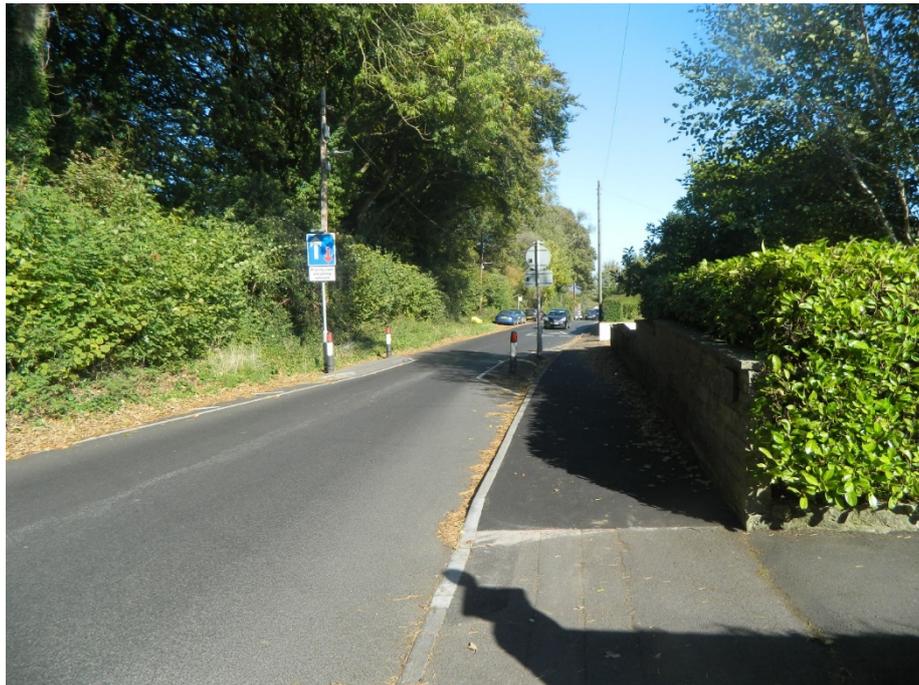
Image 3: Priority over oncoming traffic as part of traffic calming

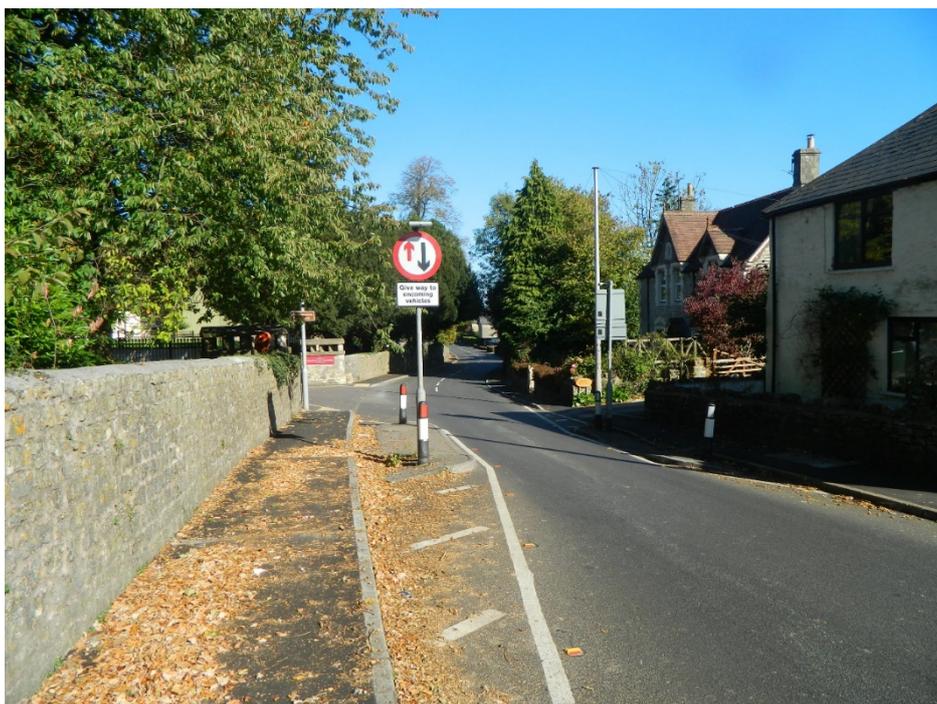
Image 4: Give way to oncoming traffic as part of traffic-calming

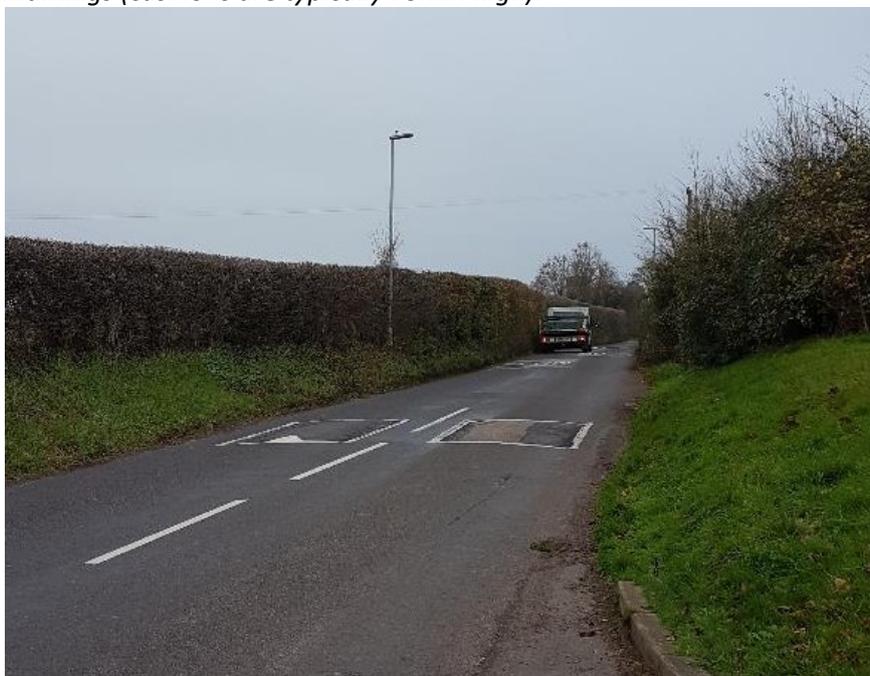
Photo of a Typical set of speed cushions, an example of vertical traffic calming, with associated street light and road markings (cushions are typically 75mm high):

Image 5: Speed cushions. Note the presence of street lighting in a rural setting

Image 5 shows a form of vertical deflection in the form of speed cushions: these are less intrusive than speed bumps as drivers can, with care, straddle them minimising the hump effect but still having to slow down.
